12
TECHNICAL REPORT M-207
March 1977

COATINGS AND CATHODIC PROTECTION OF PILINGS IN SEAWATER:
RESULTS OF 5-YEAR EXPOSURE

by
D. E. Wittmer
A. Kumar

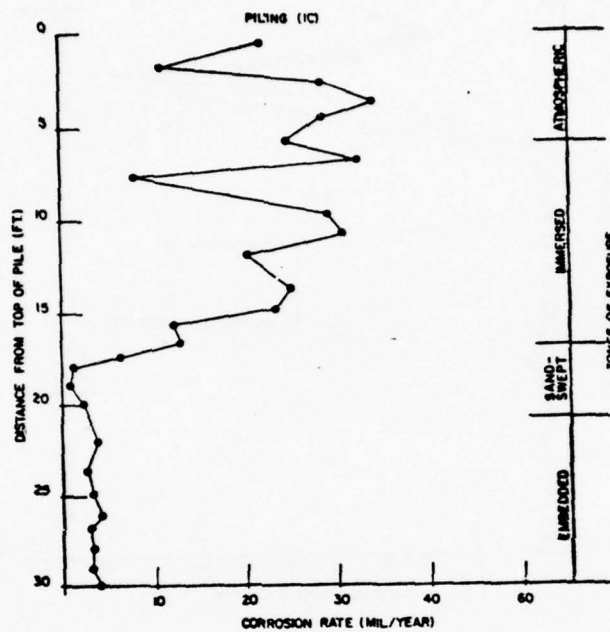
The bare piles (both unprotected and protected) were rated to obtain a surface factor to be used in the structural analysis (Table 4). As the table indicates, only the mariner steel with zinc anodes provided better than a poor surface. The other bare piles were corroded severely in the atmospheric zone, with less corrosion in the immersed zone. Corrosion was minimal and no evidence of pitting was present on the cathodically protected piles. Because the anodes protect against corrosion only in the immersed section of the piles (the salt water acts as a medium for electron exchange), the air-exposed portion (atmospheric zone) is free to corrode. This is the zone where significant corrosion occurred. The bare mariner steel provided somewhat better protection than the bare carbon steel, which was severely pitted and contained holes in the web.

Figure 15. Corrosion profile of bare carbon steel. SI conversion factors: 1 ft = 0.3048 m; 1 mil = 0.0254 mm.

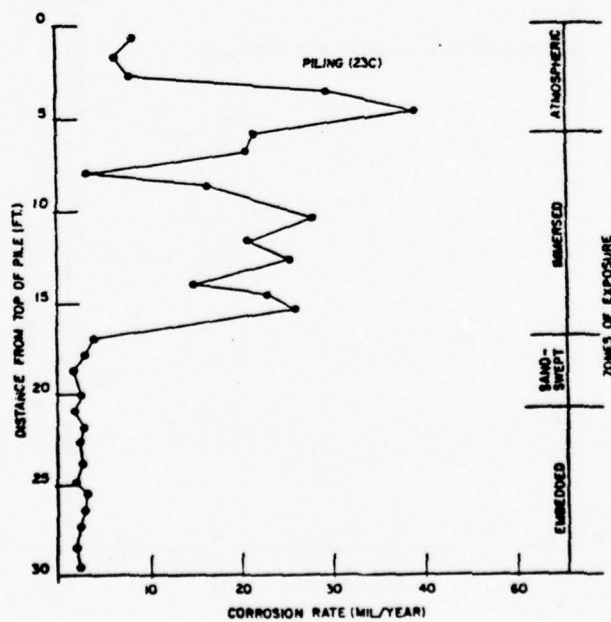
Figure 16. Corrosion profile of bare mariner steel. SI conversion factors: 1 ft = 0.3048 m; 1 mil = 0.0254 mm.

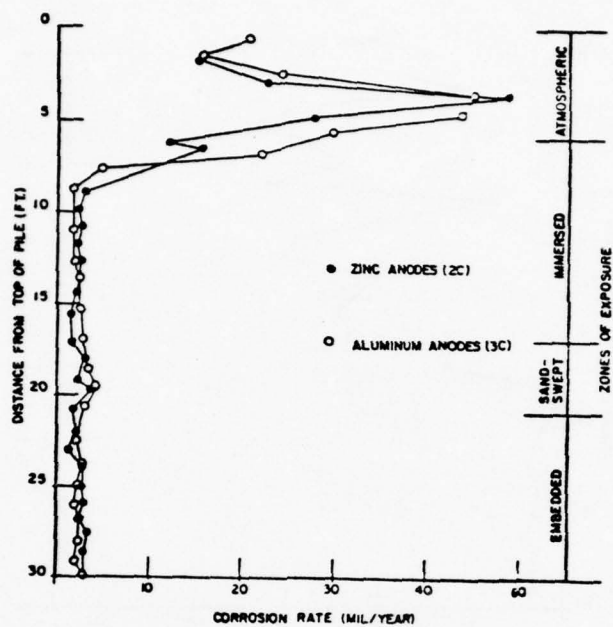
Figure 17. Corrosion profile of cathodically protected bare carbon steel. SI conversion factors: 1 ft = 0.3048 m; 1 mil = 0.0254 mm.

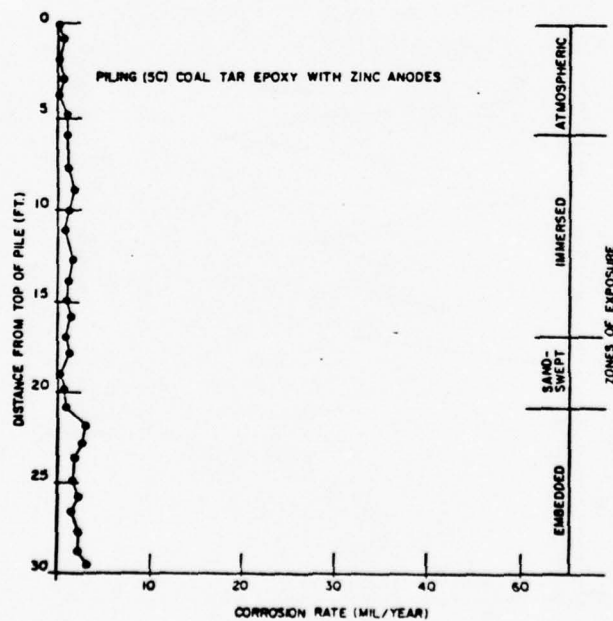
Figure 18. Corrosion profile of coated, cathodically protected piling. SI conversion factors: 1 ft = 0.3048 m; 1 mil = 0.0254 mm.

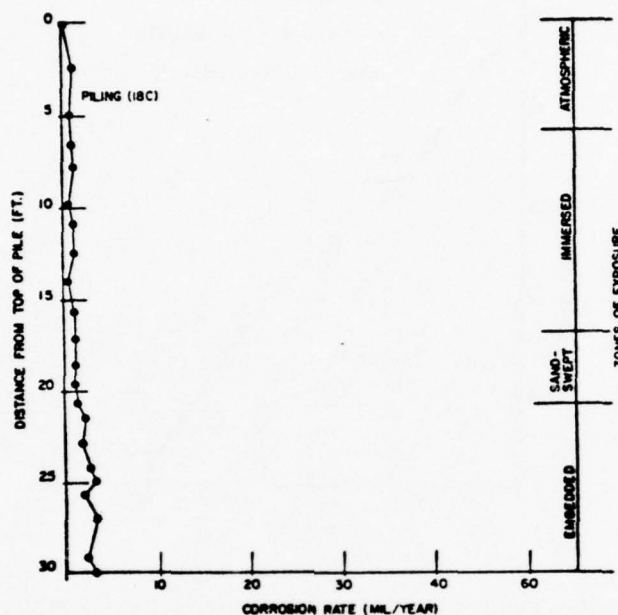
Figure 19. Corrosion profile of coal-tar epoxy over organic zinc-rich primer. SI conversion factors: 1 ft = 0.3048 m; 1 mil = 0.0254 mm.

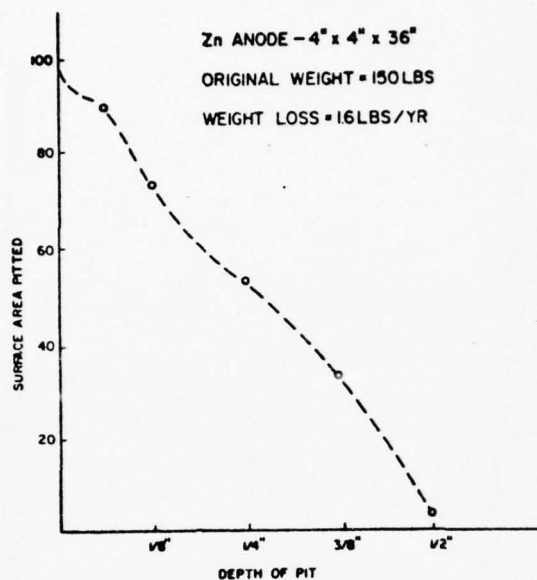
Figure 20. Pit distribution for zinc anodes. SI conversion factors: 1 in. = 2.54 cm; 1 lb = 0.4536 kg.

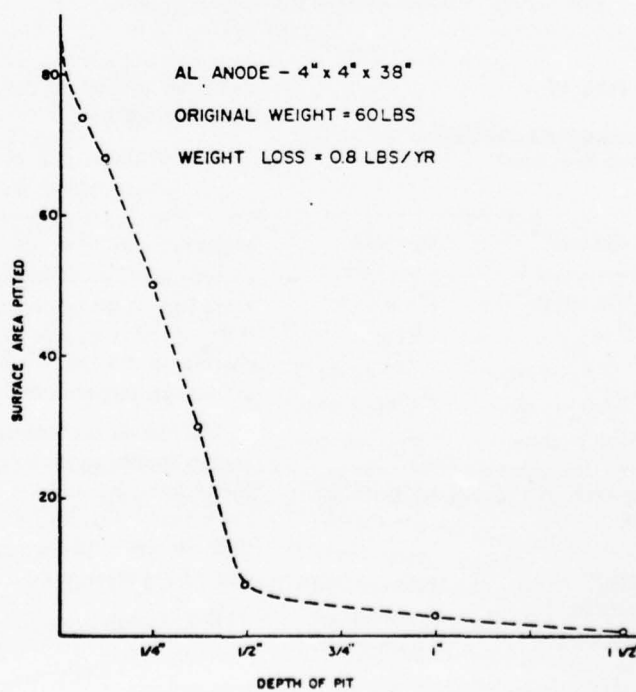
Figure 21. Pit distribution for aluminum anodes. SI conversion factors: 1 in. = 2.54 cm; 1 lb = 0.4536 kg.

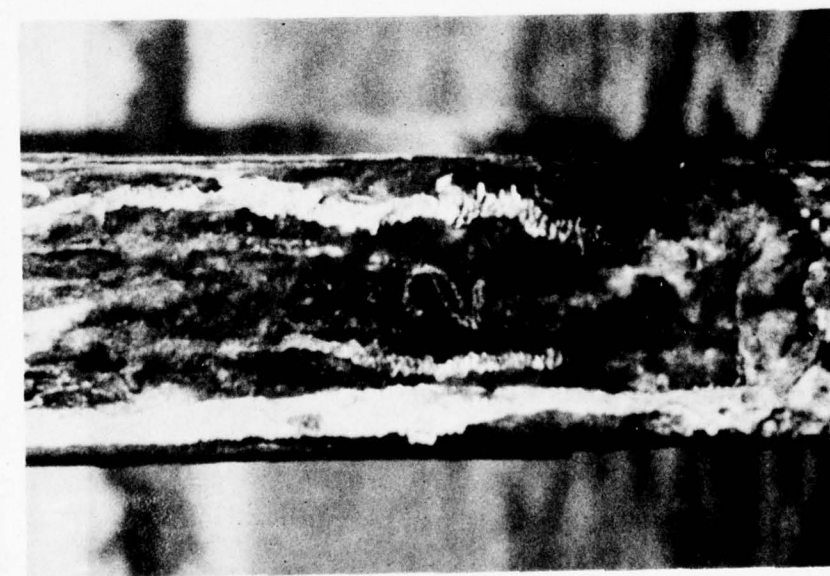
Figure A2. Atmospheric zone of bare carbon steel with zinc anodes. Absence of protection against corrosion in the atmospheric zone is evident.

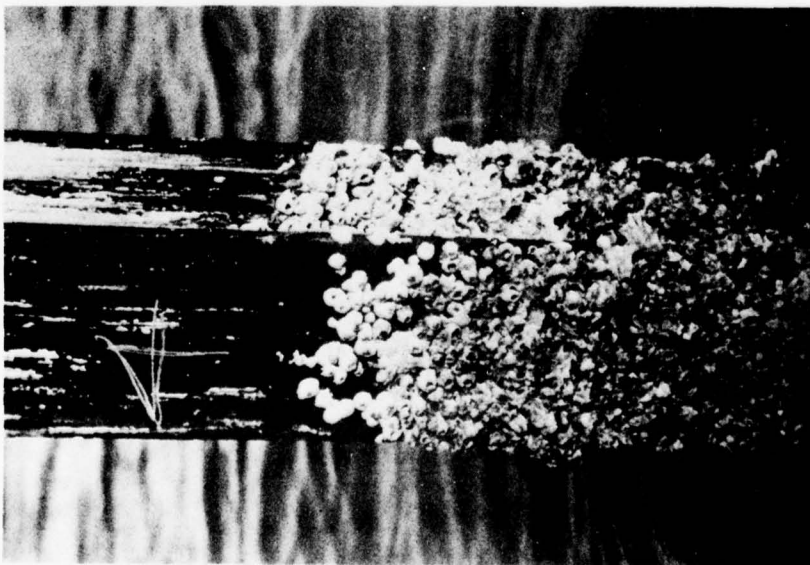
Figure A4. Coal-tar epoxy (C-200) on carbon steel. Photograph of upper immersed and lower atmospheric zones indicates the degree of marine fouling. Some damage to the fringes is also evident.

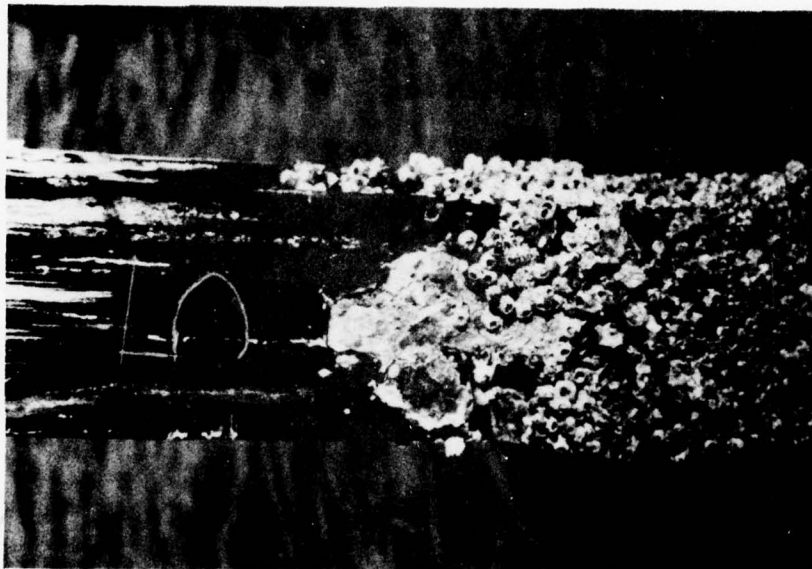
Figure A5. Coal-tar epoxy (C-200) with zinc anodes. Marine fouling is evident in the upper immersed zone, and some damage is present on the face of the pile in the atmospheric zone.

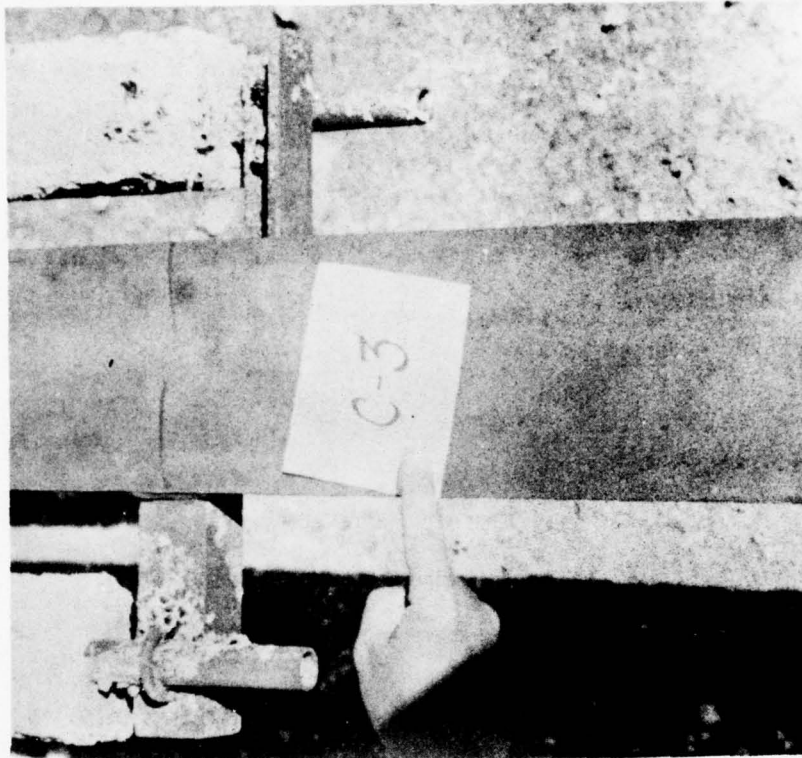
Figure A7. Bare carbon steel with aluminum anodes after 5-year removal. Protection afforded by sacrificial anodes is evidenced by lack of damage to immersed zone.

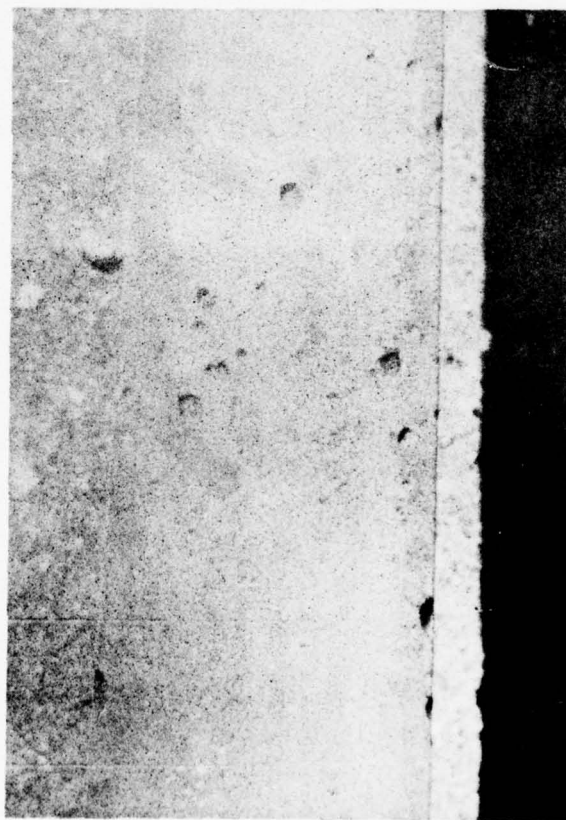
Only system 8, an aluminum-pigmented epoxy-tar, was classified as metal-filled. This coating held up excellently in the atmospheric and sand-swept zones, but suffered severe rusting, staining, and pitting in the immersed zone. Upon coating removal, the surface throughout the immersed zone was found to contain a large number of deep pits, as evidenced by the surface factor rating of 3.

Figure A9. Aluminum-pigmented epoxy tar after sandblasting. Pitting is evidence of damage in the immersed zone.

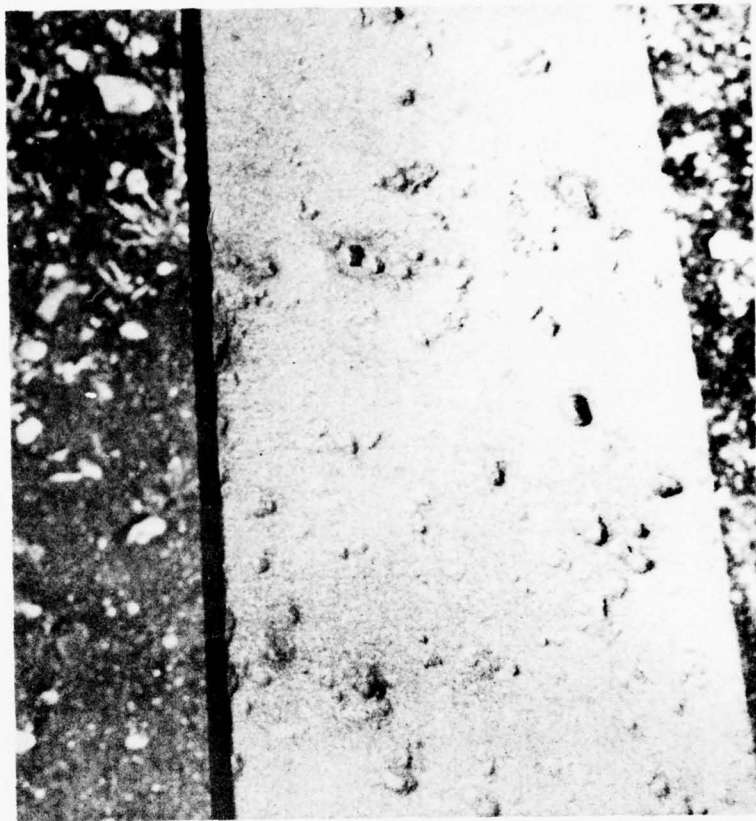
The last two systems in this classification gave poor performances in the immersed and sand-swept zones. System 21 (epoxy-tar over zinc-rich primer) performed very well in the atmospheric zone, resulting in good visual ratings during annual inspections; however, removal of the pile revealed extensive damage to the coating and pile surface. The immersed and sand-swept zones were severely pitted on all faces and flanges. The vinyl mastic over zinc-rich primer (system 22) provided only fair protection in the atmospheric zone, while the immersed and sand-swept zones received considerable damage. On coating removal, these two zones showed some surface damage in the form of a series of shallow interconnected pits on the faces and isolated pits on the edges of the flanges.

Figure A10. Epoxy-tar over zinc-rich primer after sandblasting. Severe pitting in the immersed zone is indication of structural degradation caused by corrosion.
